2183 USPS Processing & Distribution Ctr REPORT
Multnomah
Final Closure Report April 12, 2012

Final Closure Report

**USPS Portland P&DC
715 Northwest Hoyt Street
Portland, OR 97208**

April 2012

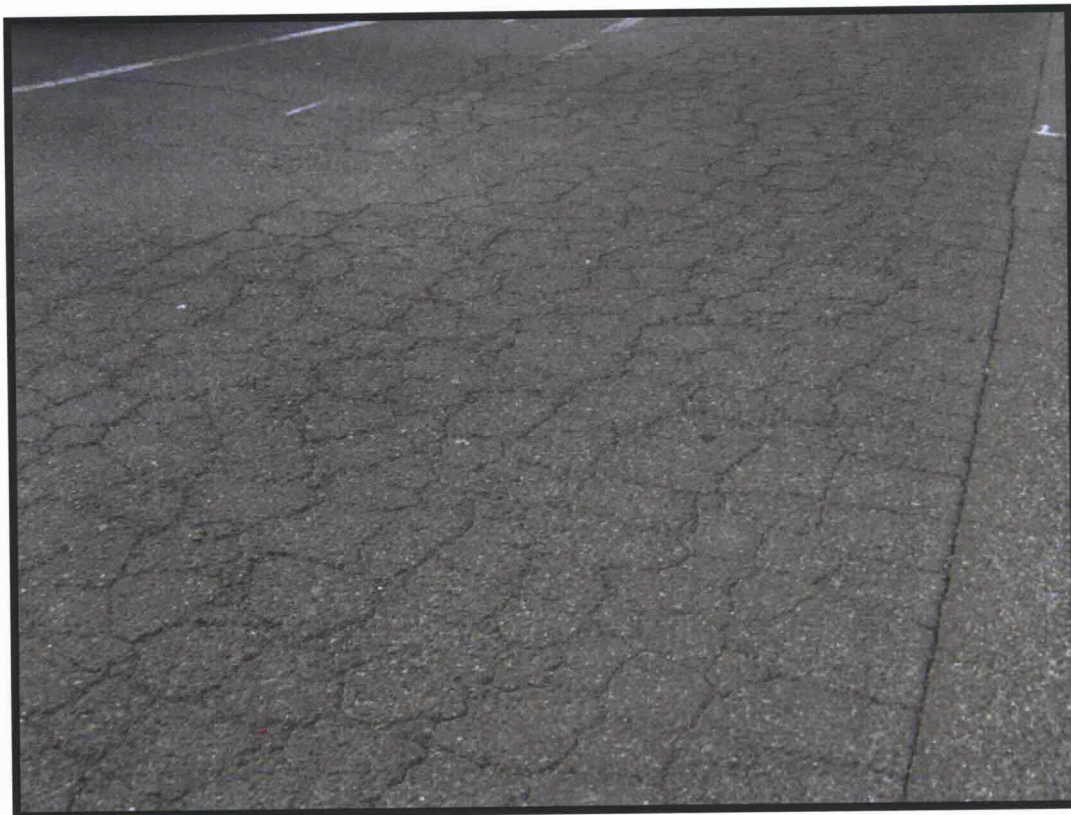
Alligatoring in pavement.

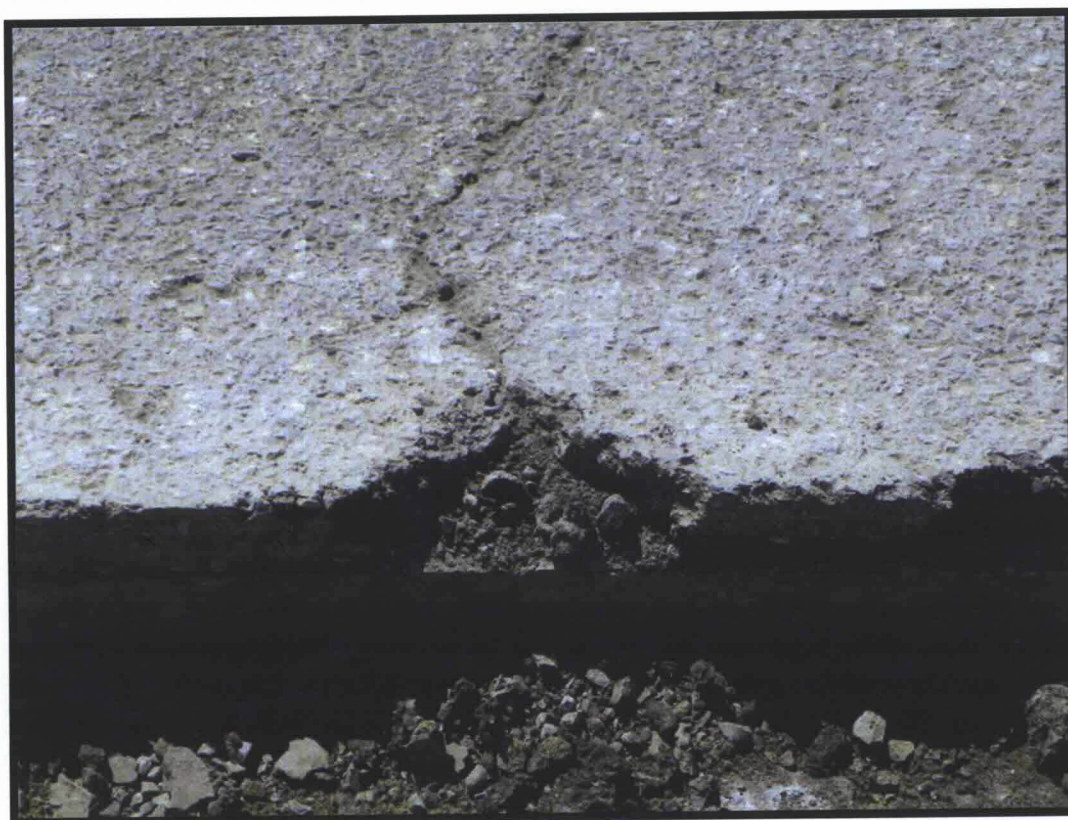
Cracking and two layers of pavement (showing existing condition during cover work).

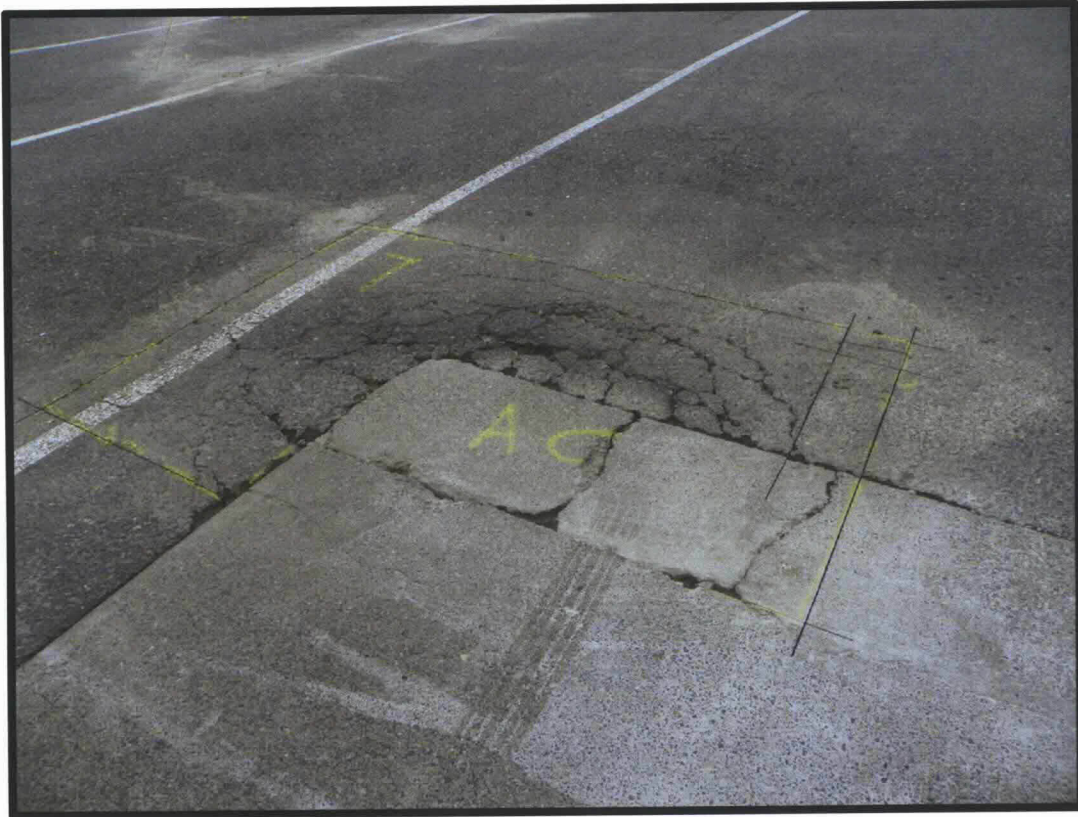
Cracking in pavement.

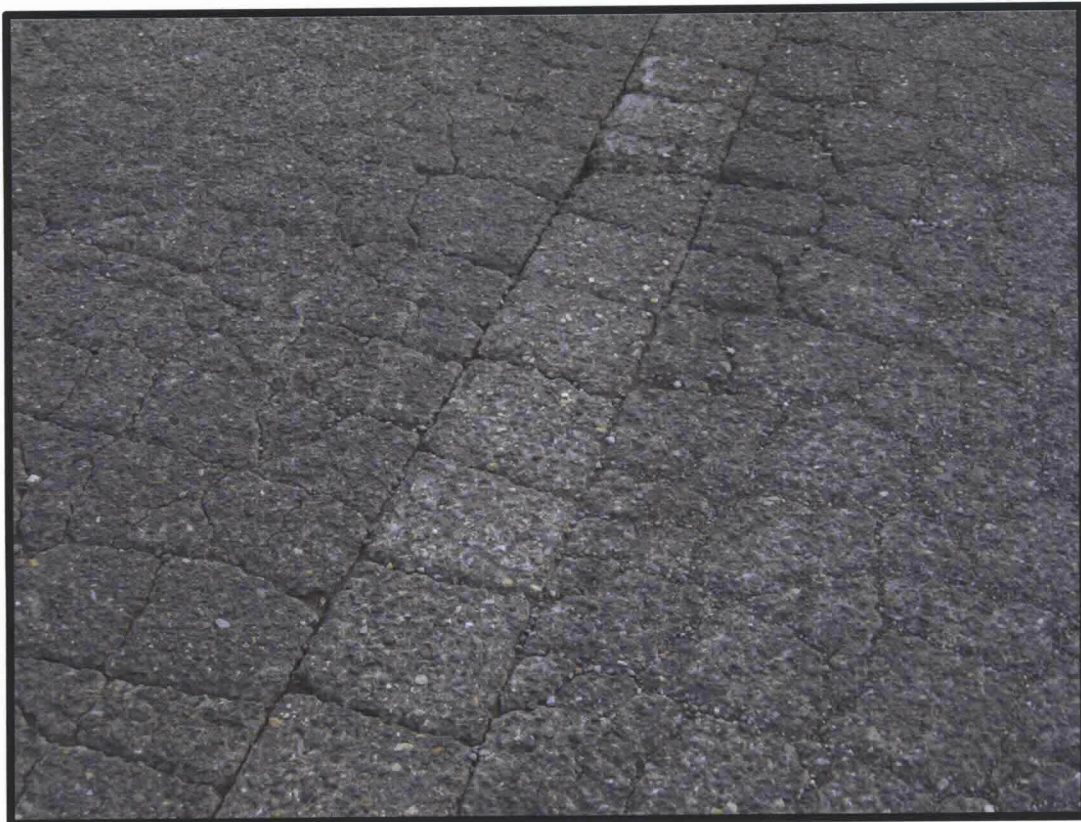
Alligatoring in pavement.

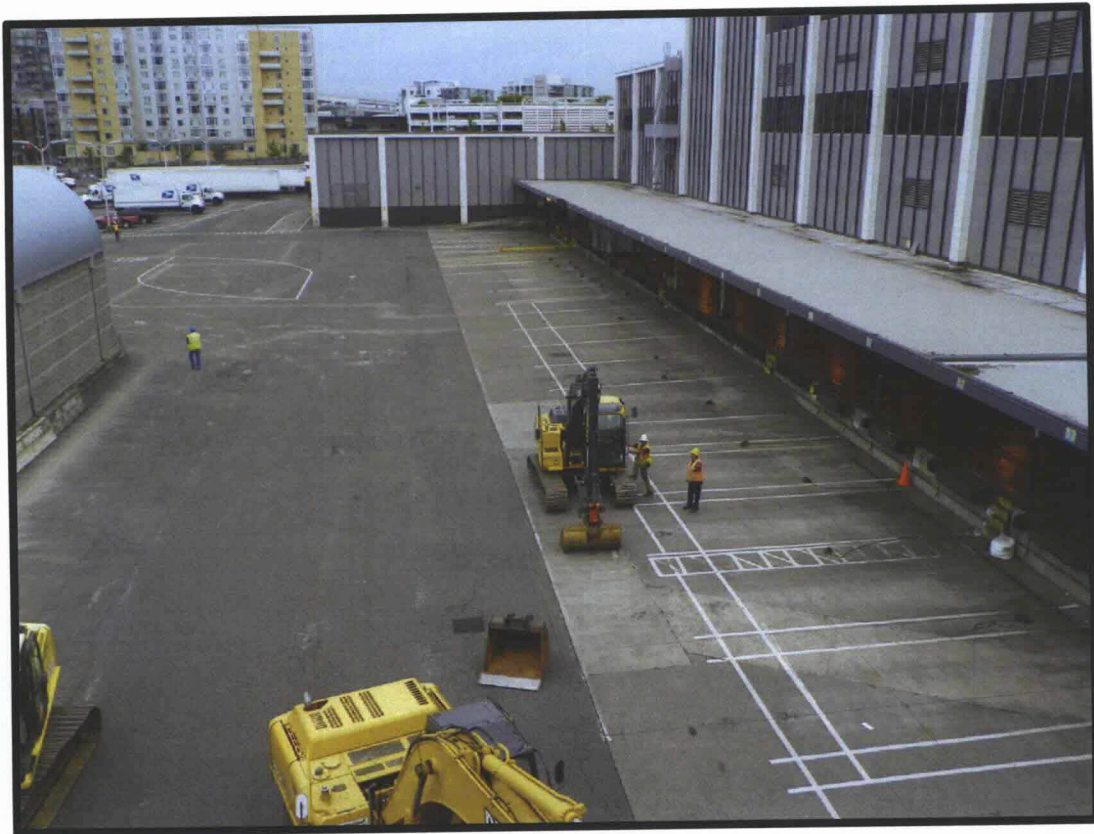
Utility Vault Area before repair work.

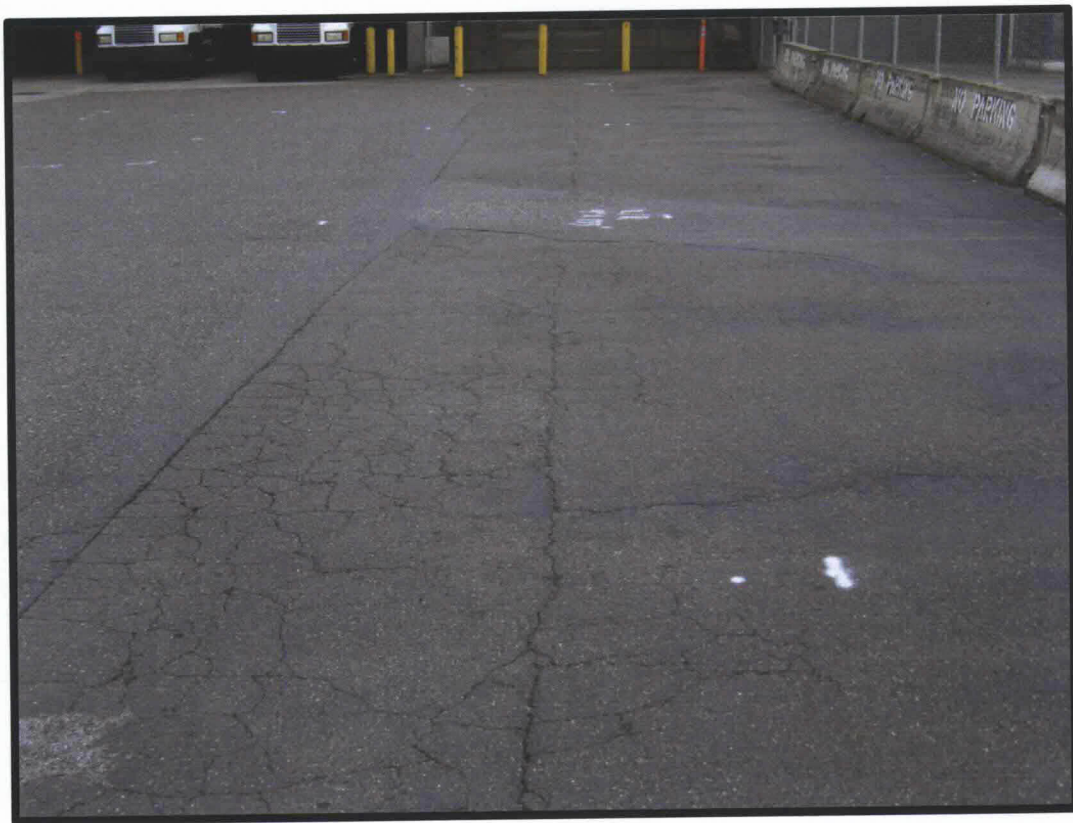
Cracking in pavement in Utility Vault Area before repair work.

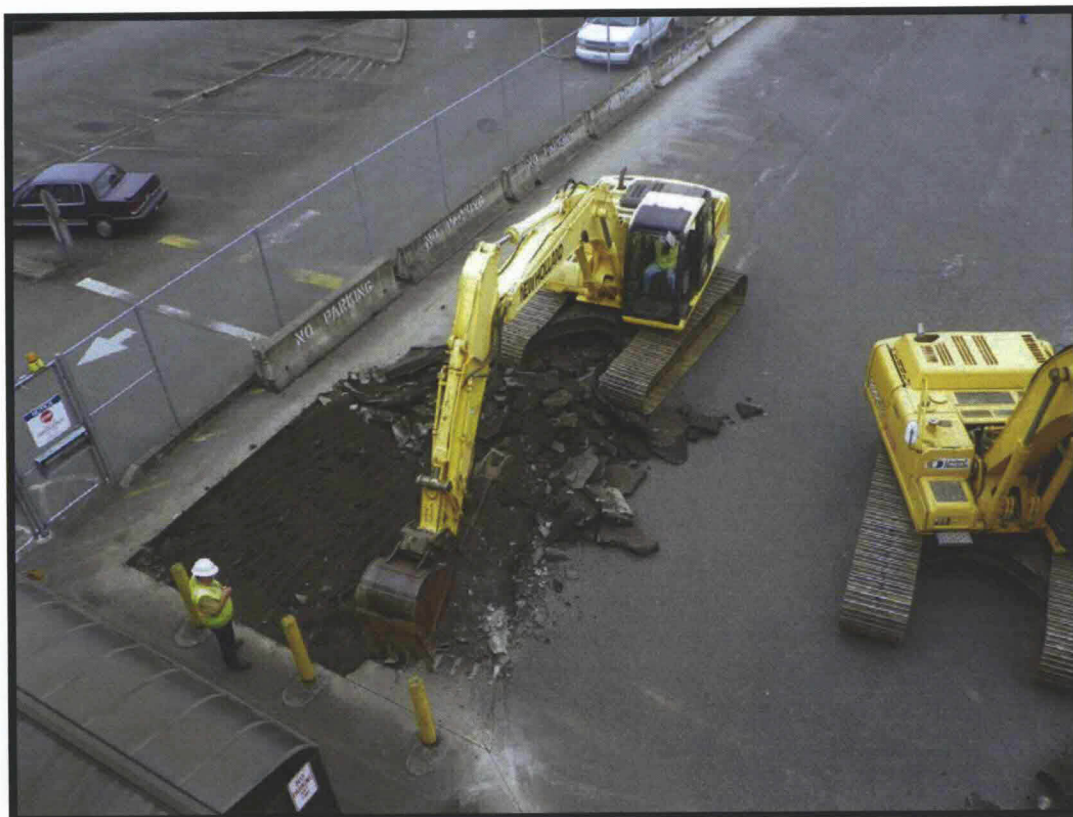
Pavement removal in Utility Vault Area.

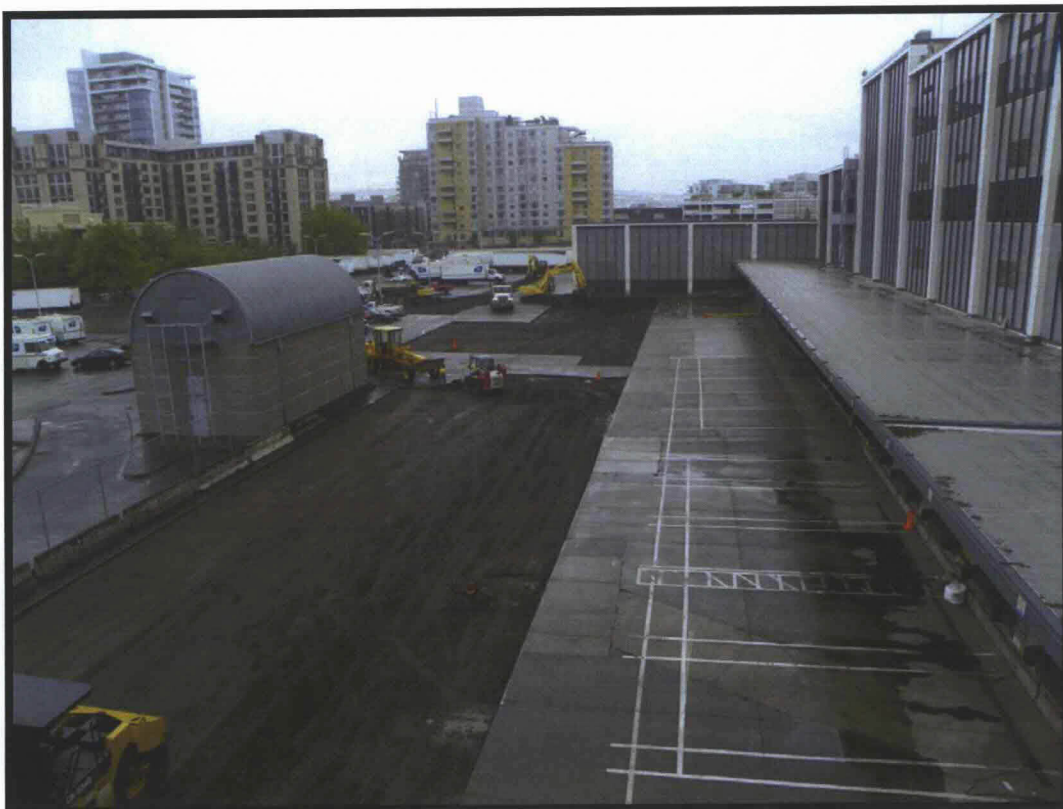
Compacting in south end and pavement removal in north end of Utility Vault Area.

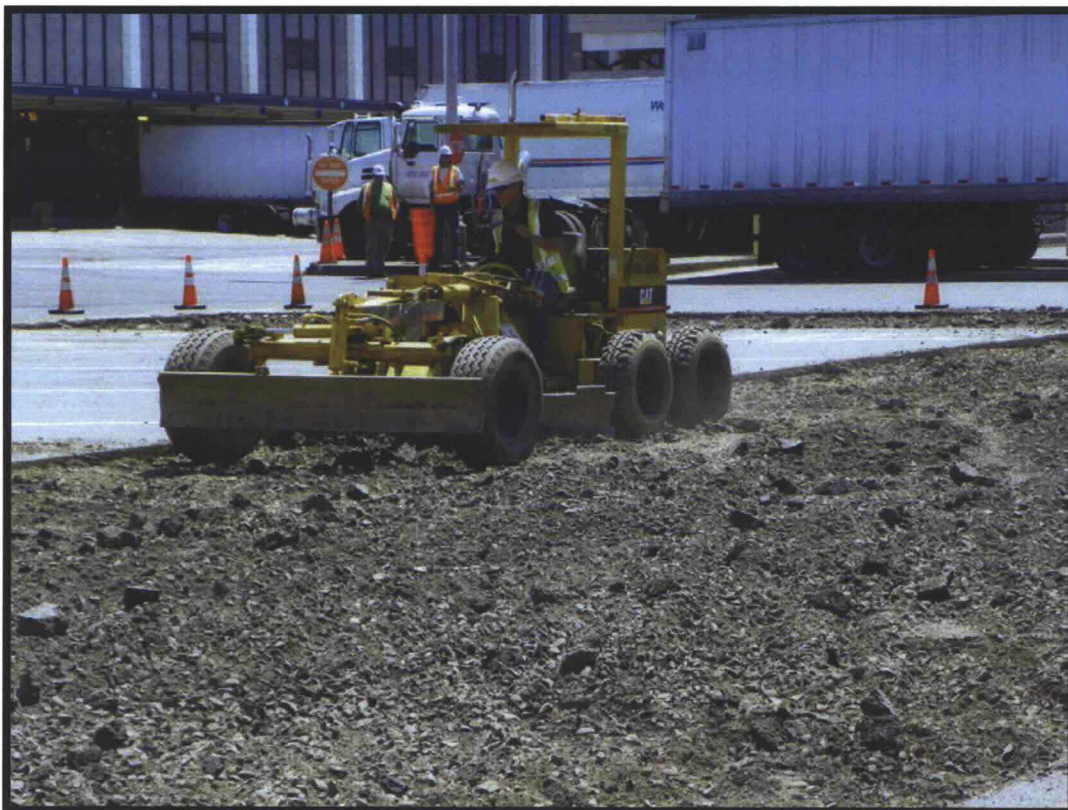
Grading in drive aisle near site entrance in former Coach Cleaning Area.

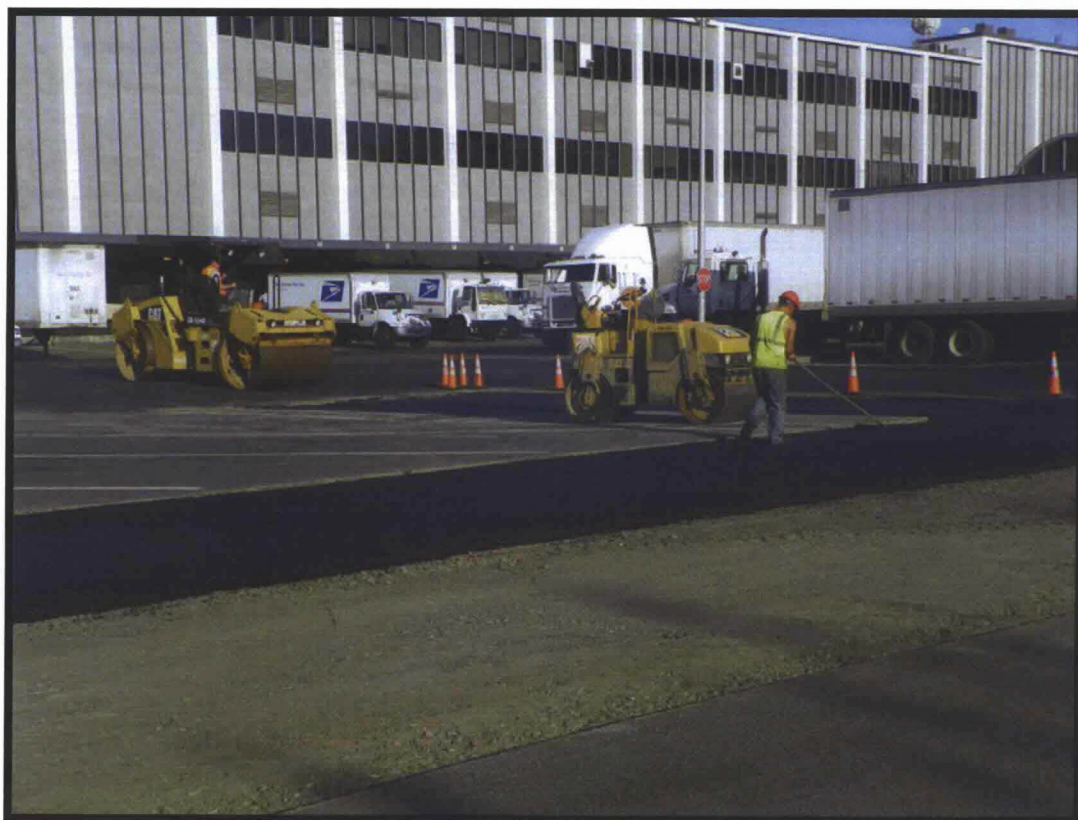
Paving placement (first lift) in drive aisle near site entrance in former Coach Cleaning Area.

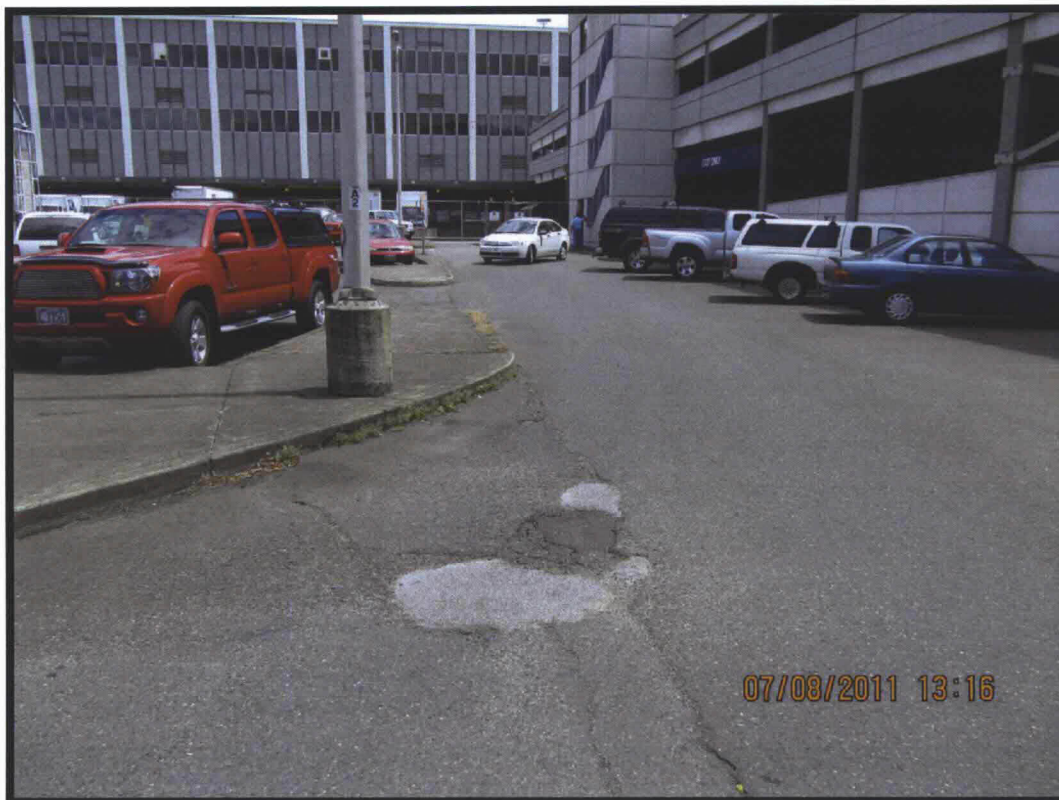
During the baseline inspection, moderate to severe cracking was observed in a small paved area approximately 10 ft by 10 ft in the employee parking lot near the northwest corner of the parking garage. This area was repaired on August 3, 2011, in the same manner that repairs were completed in other areas as described in Section 4.1.1.1, which resulted in a final paving thickness of approximately 4 in. A photograph of this repaired area is provided in Appendix D. Photographs of this area before and after repair are provided in Appendix C.

Cracked and patched area in pavement in employee parking lot before repair work.

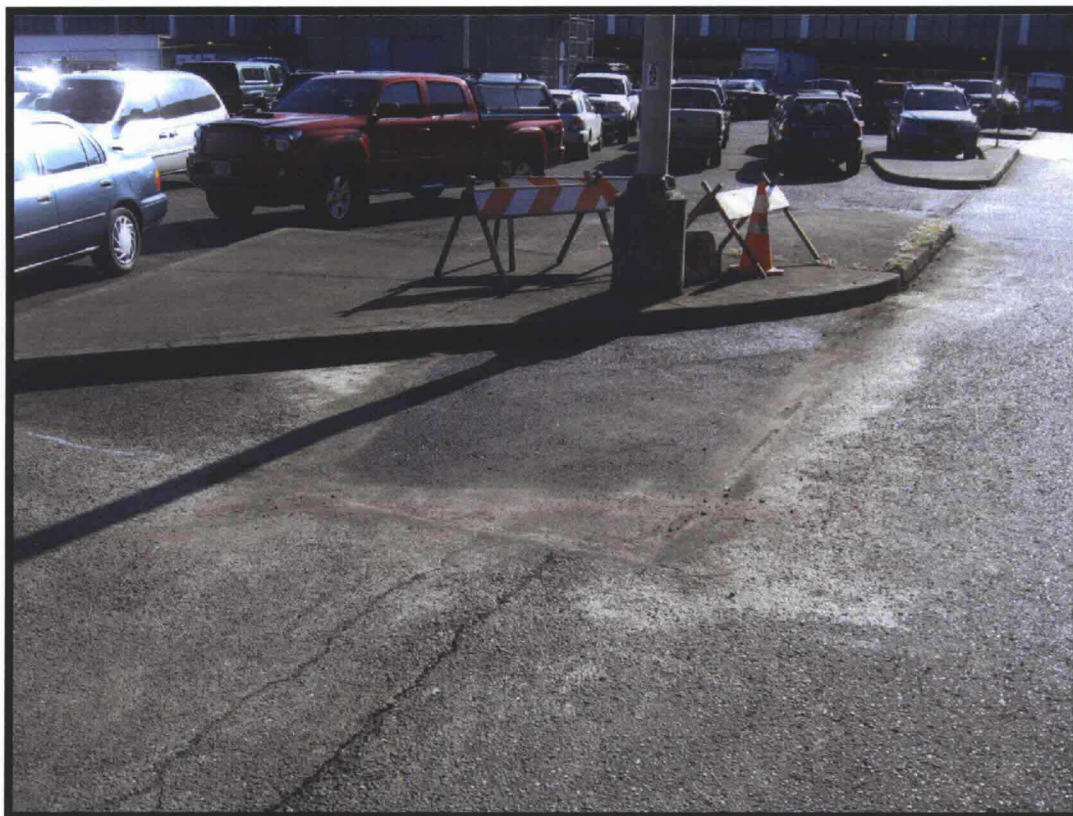
Cracked and patched area in pavement in employee parking lot after repair work.

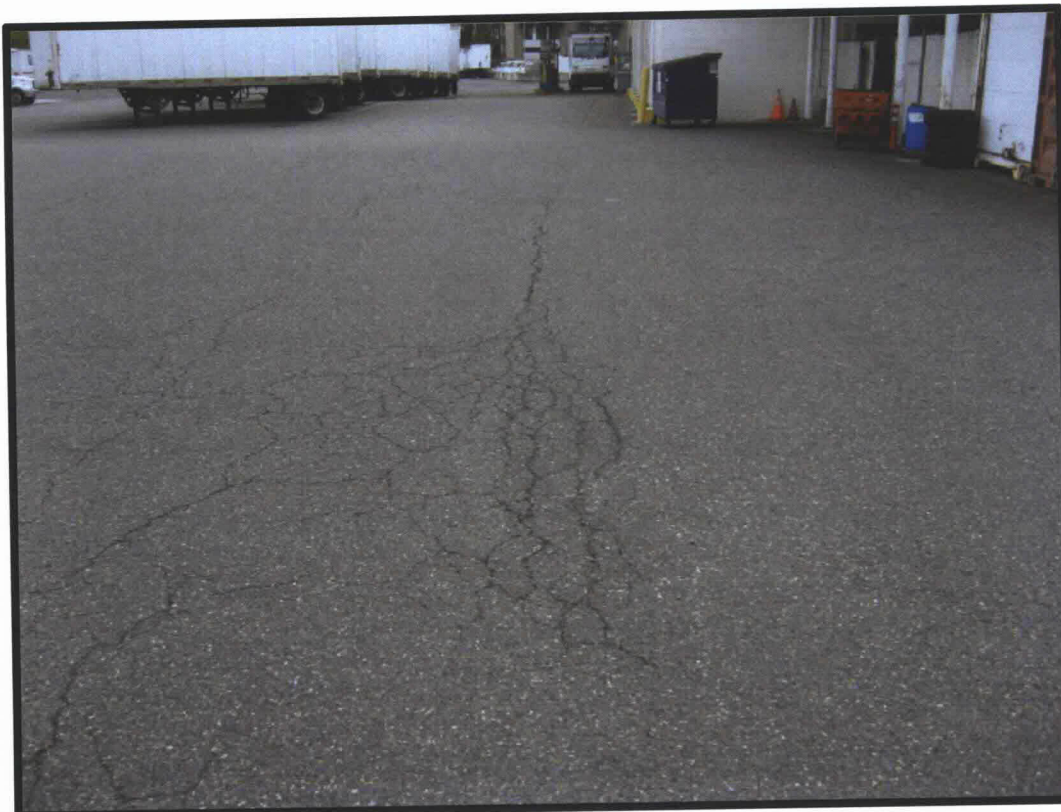
Cracking in pavement in Vehicle Maintenance Facility (VMF) Area.

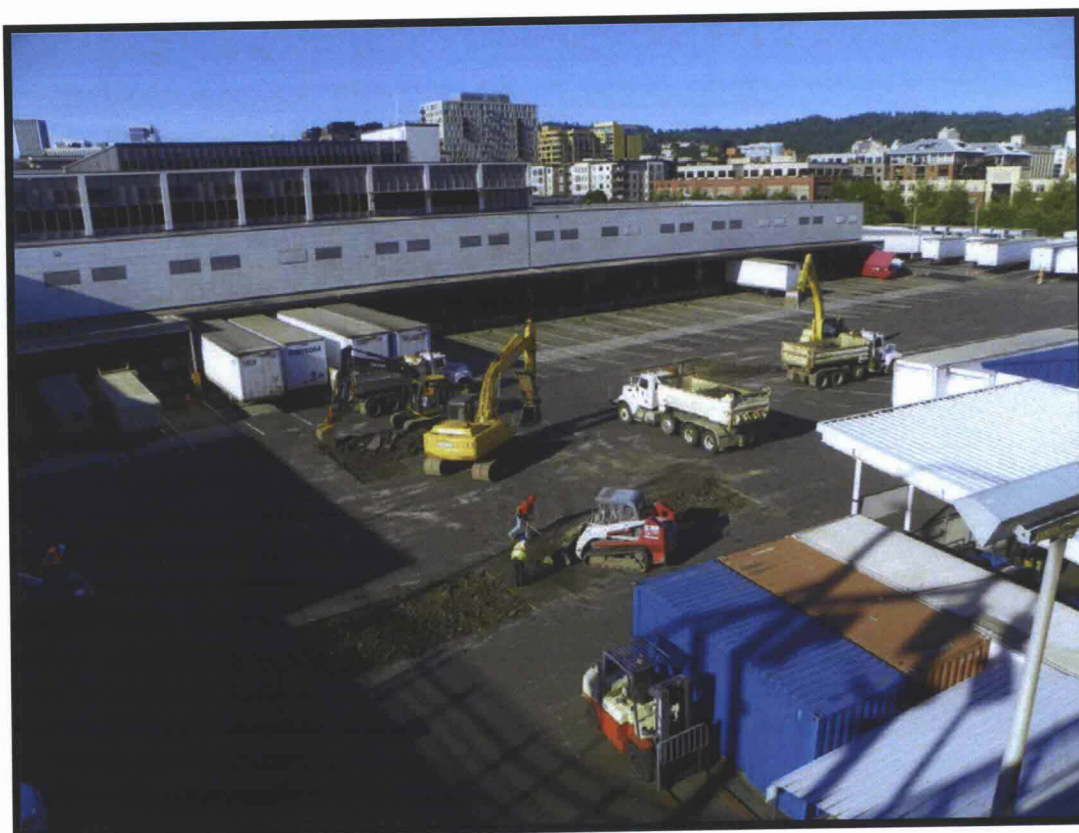
Pavement removal in VMF Area and Northeast Corner Area.

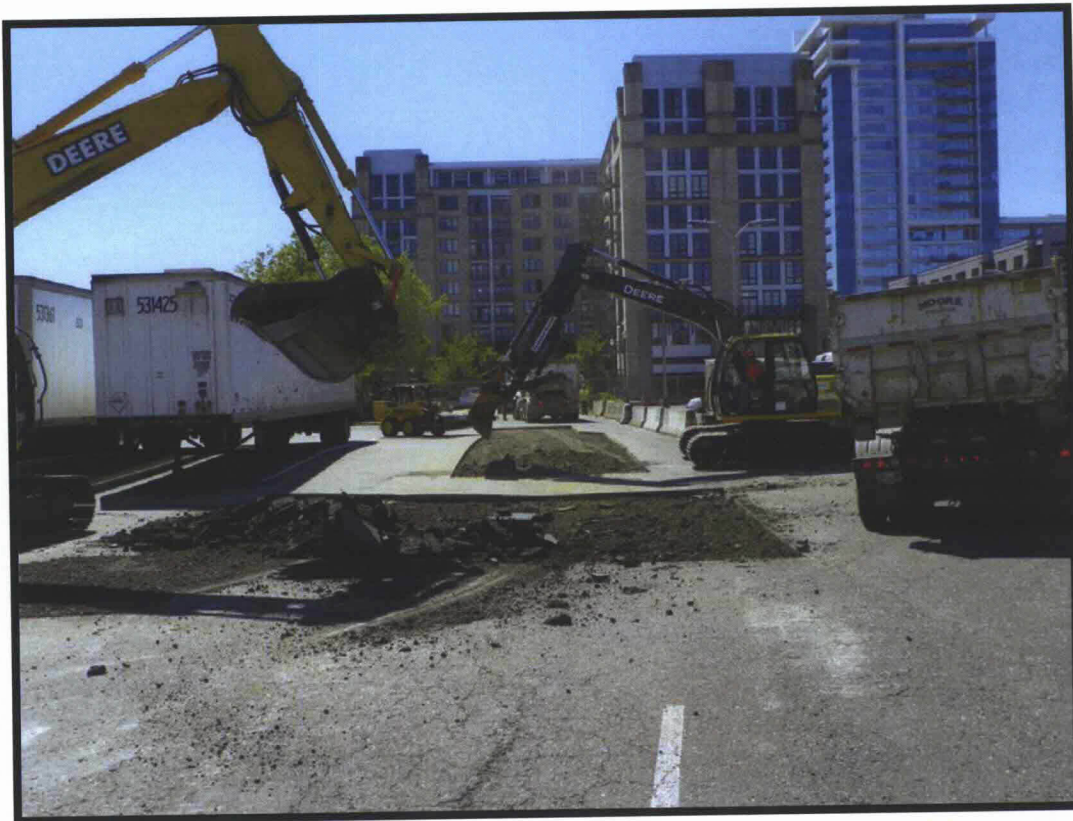
Pavement removal in VMF Area.

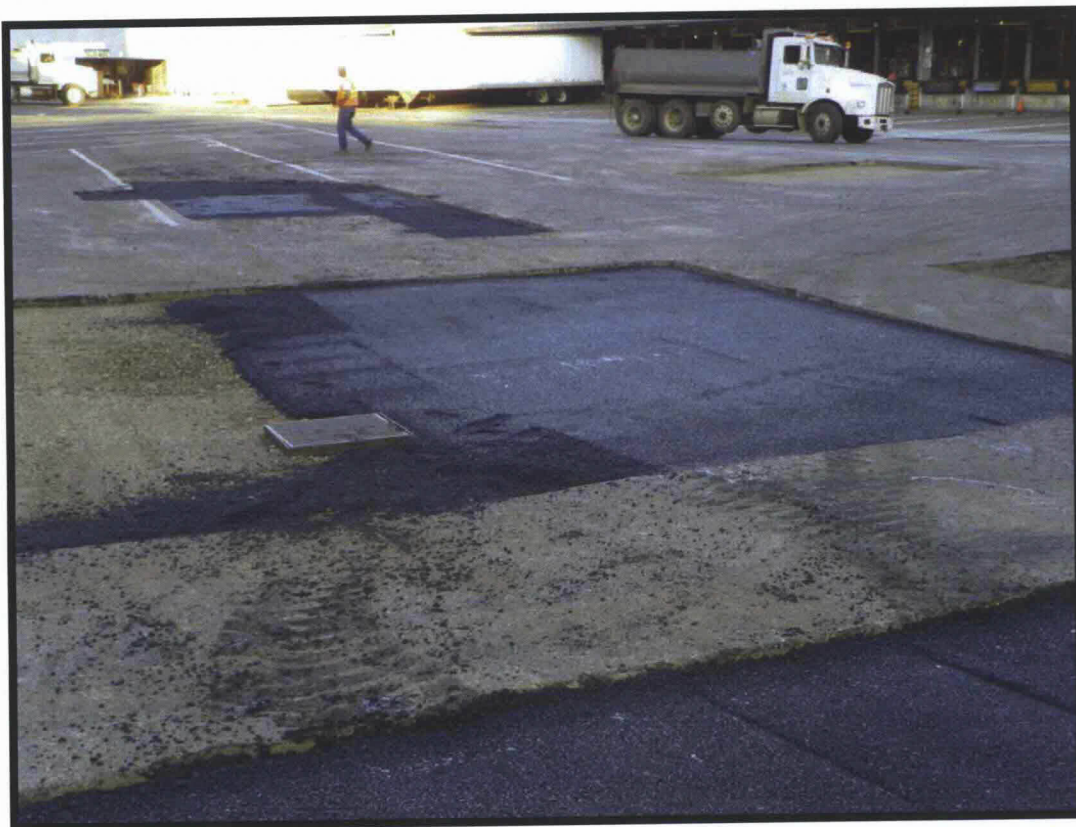
Placement of pavement (first lift) in VMF Area.

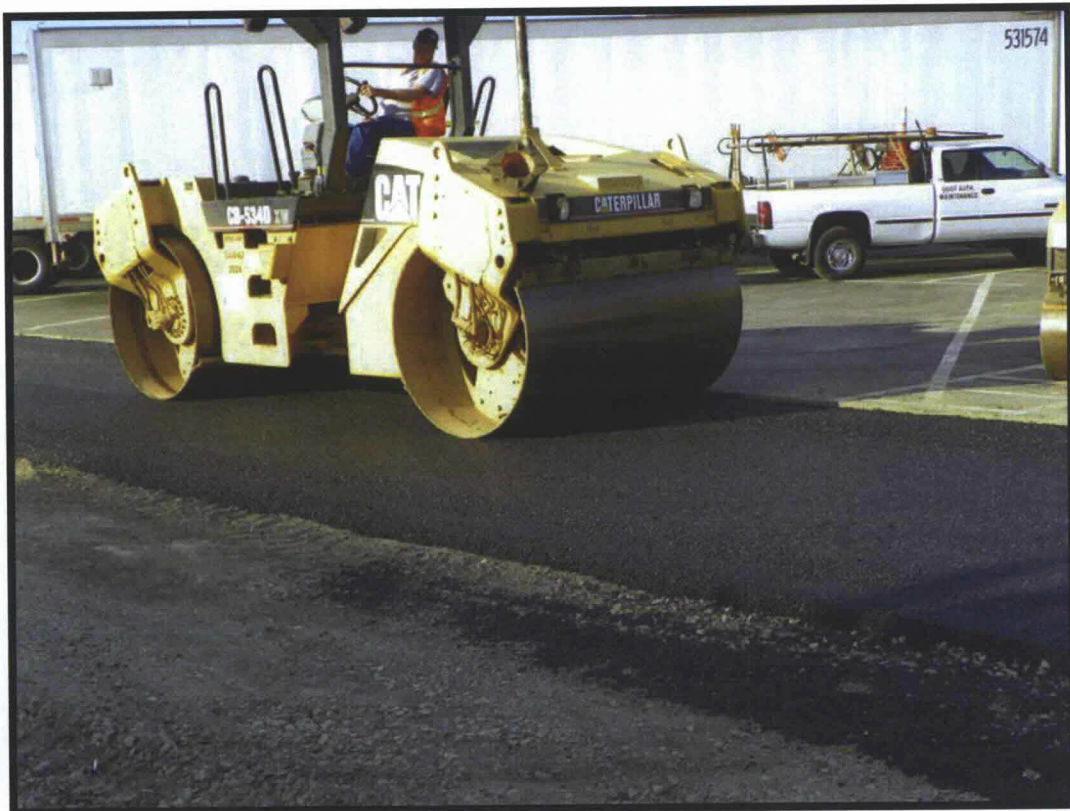
Pavement rolling/compacting in VMF Area.

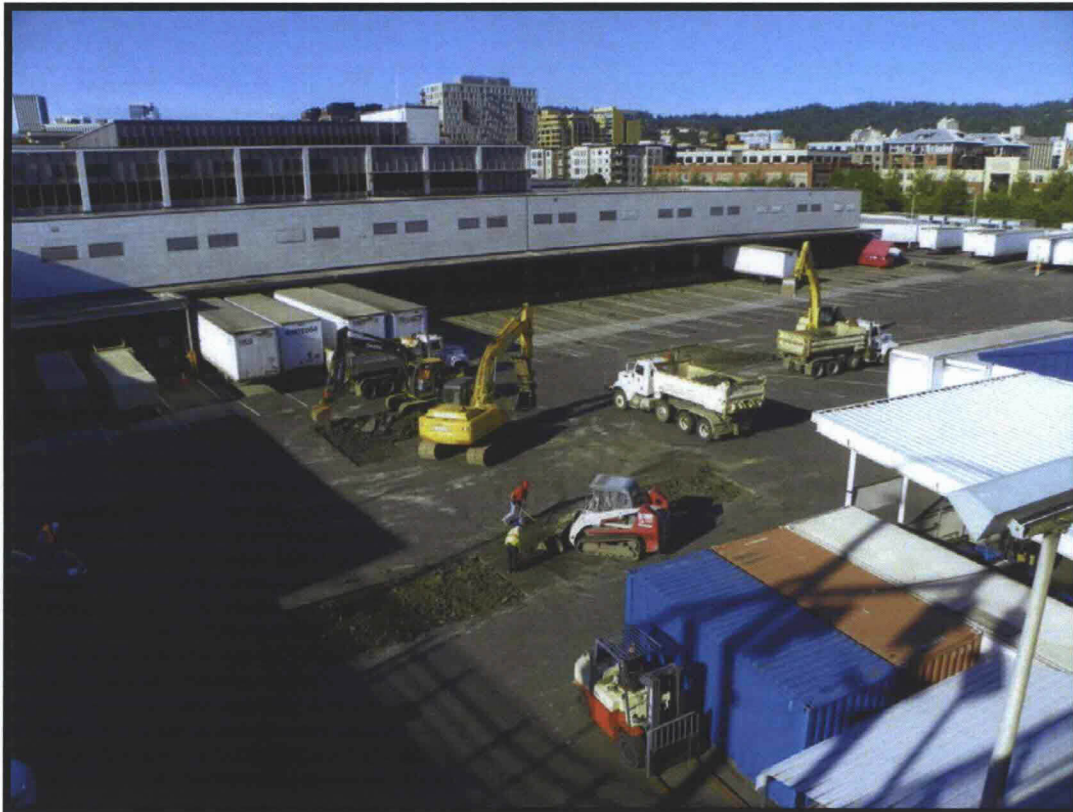
Pavement removal in VMF Area and Northeast Corner Area.

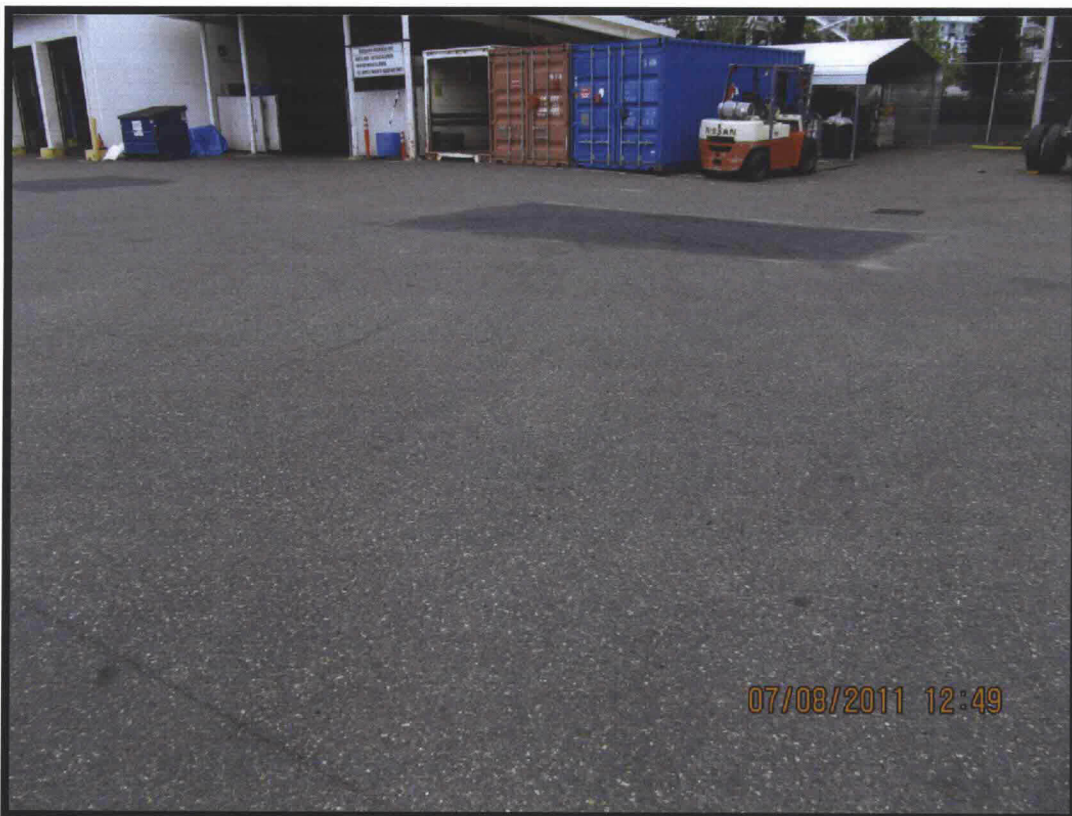
Repaired pavement in Northeast Corner Area.

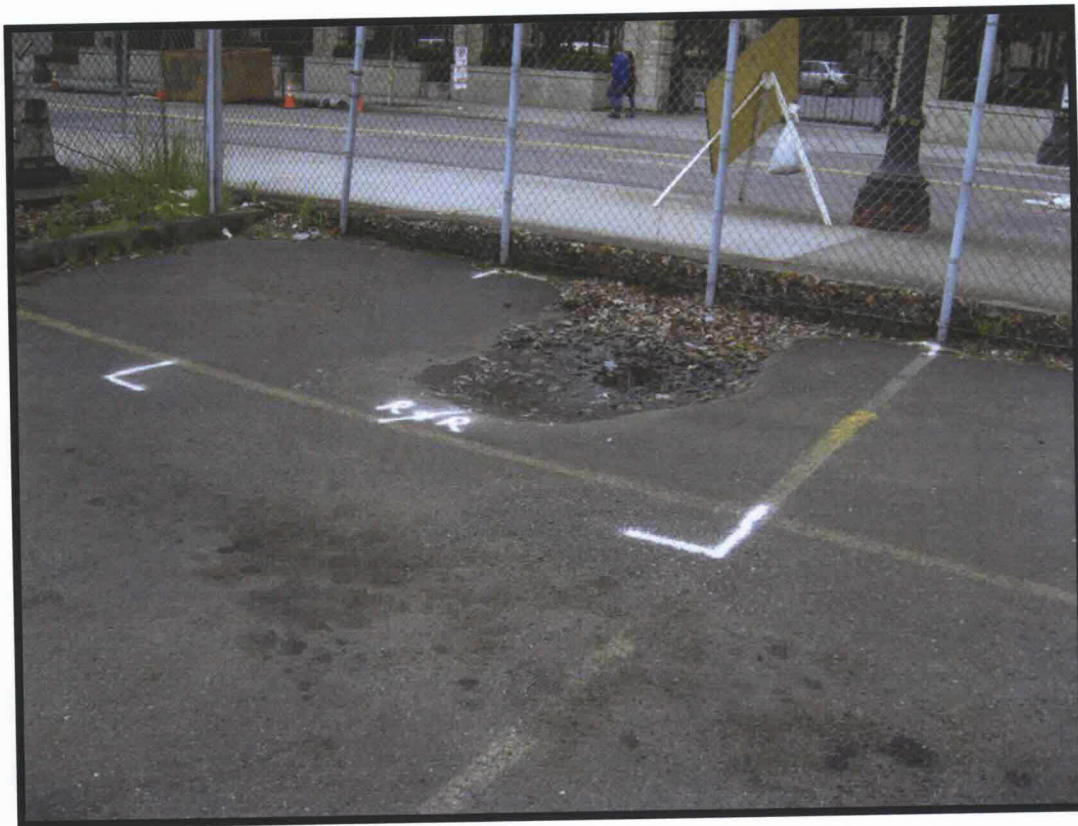
Low-lying area in Pintsch Plant Area before repair work.

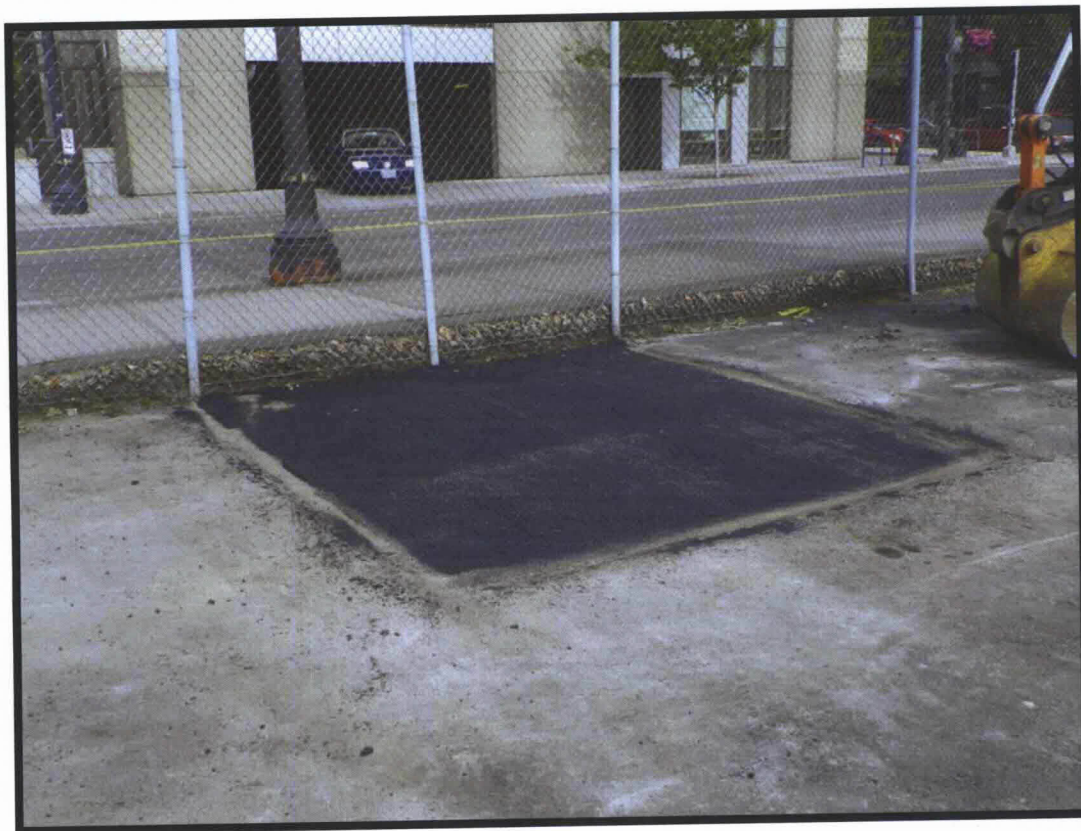
Low-lying area in Pintsch Plant Area after repair work.

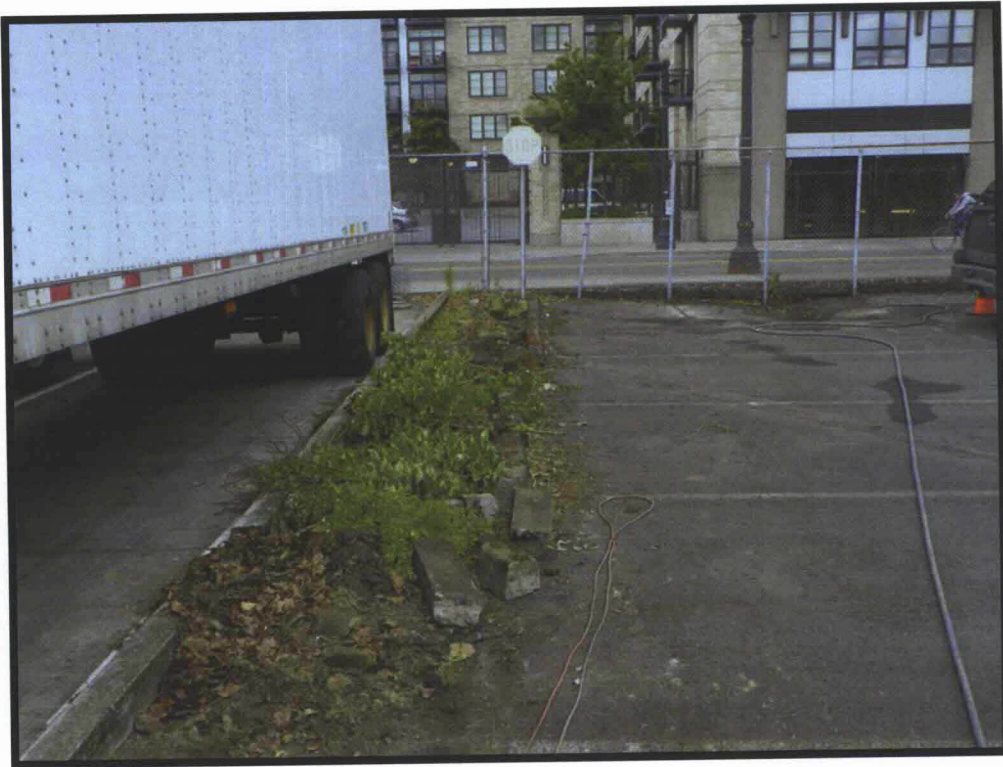
Area of planter and damaged curbing along north side of abandoned driveway before repair work.

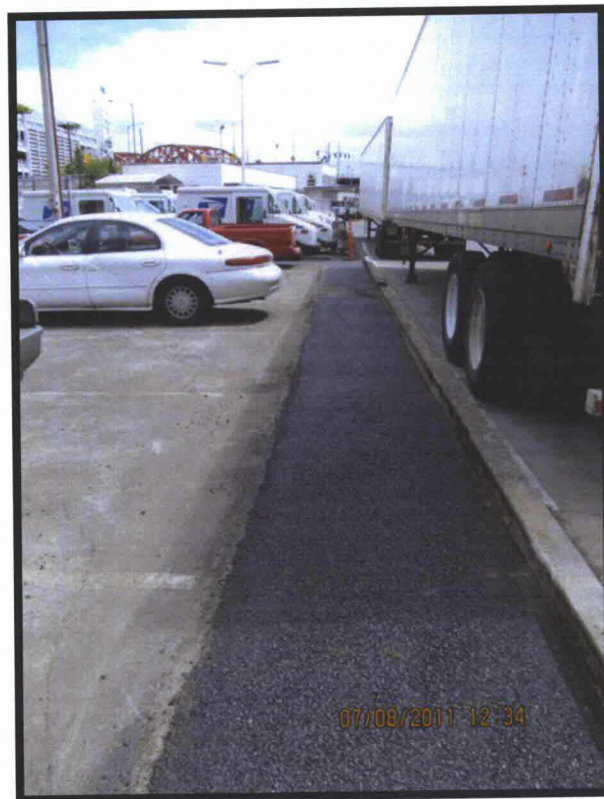
Area of planter and damaged curbing along north side of abandoned driveway after repair work.

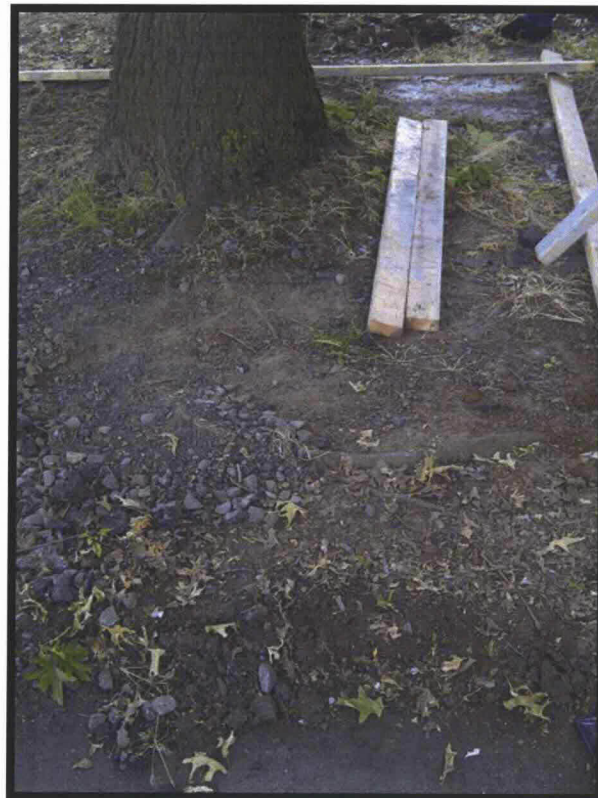
Shallow tree roots prevented soil removal to a depth of 12 in. in the landscaped areas. Rather, soil was removed with hand tools as conditions allowed to a maximum depth of approximately 4 in. In most areas no more than 2 in. of soil could be removed without damaging the roots. Following soil removal, a demarcation layer was added, and areas were filled with clean size 1½-in. washed drain rock. The landscaped area along the north side of the Site entrance was removed and filled with concrete.

Tree roots at surface in Pintsch Plant Area before repair work.

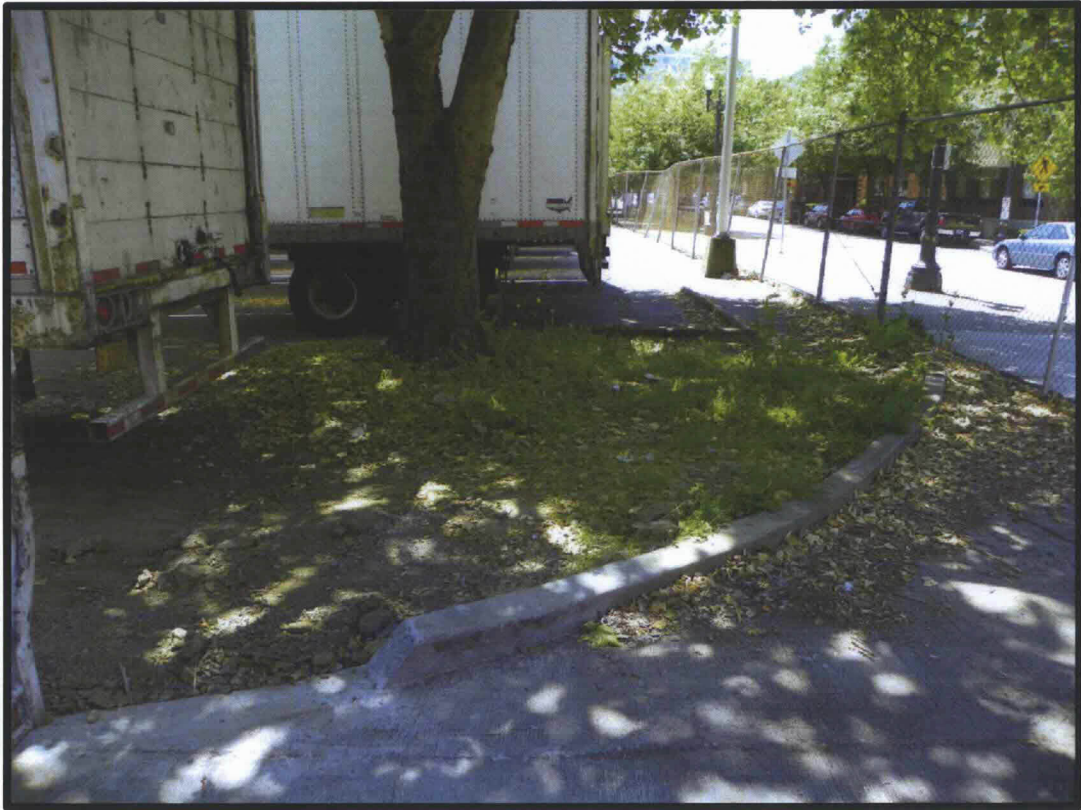
Tree in Pintsch Plant Area before repair work.

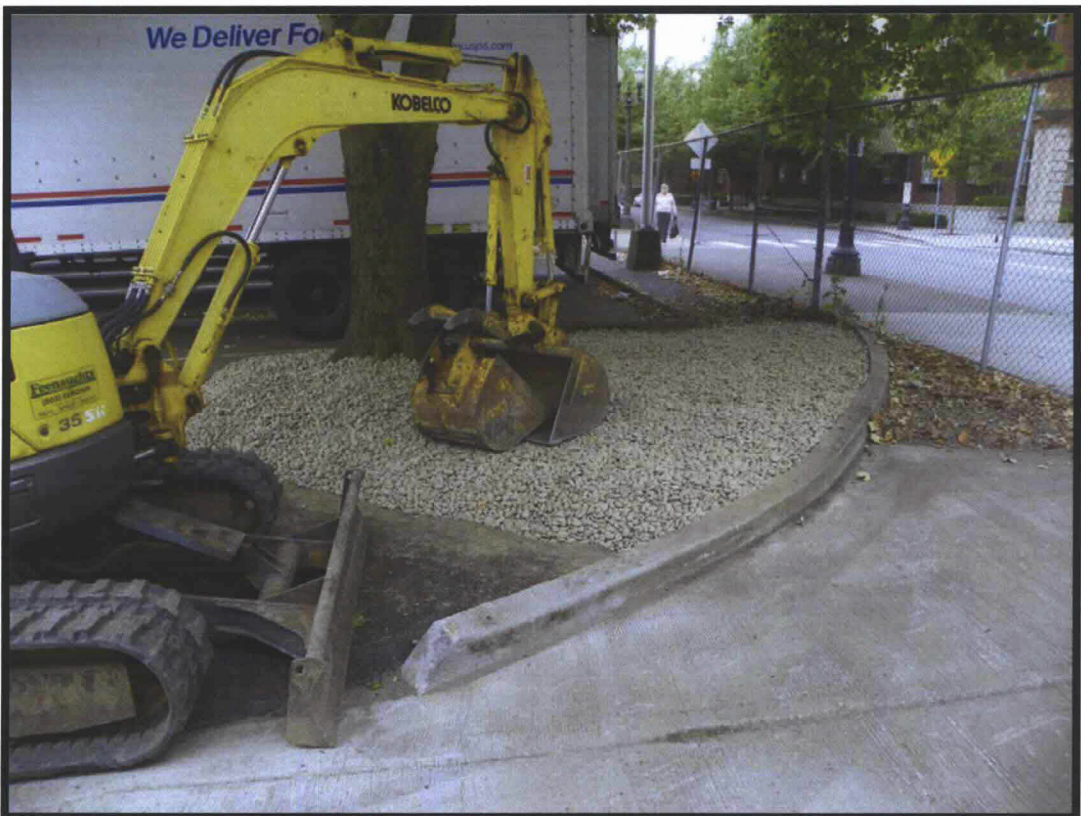
Tree in Pintsch Plant Area during repair work.
